# Line II of Warsaw Underground: the excavation of tunnel connector (Centrum Nauki Kopernik station) under existing Wislostrada tunnel

V. Capata<sup>1</sup>, A. Lombardi<sup>2\*</sup>, F. Bizzi<sup>3</sup>

**ABSTRACT** The Centrum Nauki Kopernik station of the Line II of the Warsaw Underground is located along and close the Vistula river. The station consist of three parts: the east and west shaft and one connecting tunnel of large cross section (170 m<sup>2</sup>), which includes the rails along the sides and the platform along the center. The reason for the underground connection of two shafts with a tunnel is due to the presence of a road tunnel, which must be underpassed by the new metro line. The existing tunnel (Wislostrada) was built between diaphragms walls by top-down method and some foundation parts of its structures interfere with the underground tunnel. The challenging target was to build the connectors without stopping the traffic of vehicles along the above highway. All works have occurred in very difficult geological and hydraulic conditions due to the presence of Vistula alluvial deposits of poor mechanical characteristics. In particular the soil profile consists

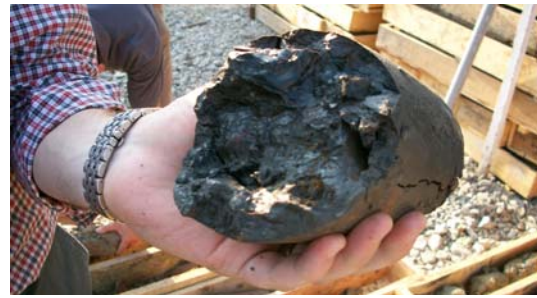
**Figure 2.** Sample of Pliocene clay

The subsoil consists of upper Cretaceous deposits overlain by Tertiary (Oligocene, Miocene and Pliocene) and Quaternary soils. The top of the Tertiary deposits is mainly caused by processes of erosion and glaciectonic origin. The Pliocene deposits consists of high plasticity clays and stiff silty clays (Figure 2).

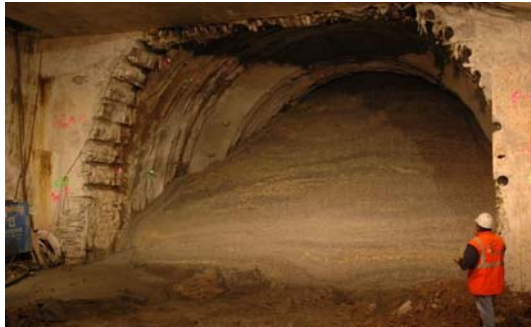
**Figure 6.** Collapse of north tunnel

At first to taking into account this stratigraphic variability to protect the top half of the tunnel (in sand) was considered to apply jet grouting system, but collapse of north west tunnel occurred (Figure 6) during execution before reaching the sandy layer.

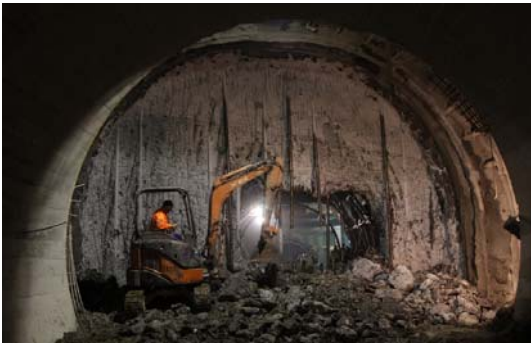
**Figure 10.** WS barrettes demolition

During several visits on the site it was possible to observe the excellent behavior of the face as a result of soil freezing. Due to the strength and hardness of the iced soil was necessary to use the point cutter in order to proceed with tunnel excavation. The excavation proceeded without particular problems and never results in instability phenomena. Even cutting of central barrettes of the WS tunnel was completed quite quickly.
