Warsaw line II metro extension: TBM excavation under historical buildings in urban environment

M. Minno & V. Capata

S.G.S. Studio Geotecnico Strutturale S.r.l., Rome, Italy

ABSTRACT: The TBM excavation for the Eastern extension of the Warsaw line II metro has been completed in January 2018 by Astaldi/Gulermak joint venture. Excavation involved mainly fine and medium sands below water table which created a challenging environment for Earth Pressure Balance (EPB) TBM works. In order to reduce settlements at ground level for selected historical buildings, ground improvement was carried out through permeation grouting with the aim at reducing volume loss during excavation and inducing an initial heave of the buildings. Also, high-standard TBM performance was achieved with the use of bentonite and polymers, specific grout mix and controlled face and grout pressures. Extensive monitoring was carried out through manual and automatic measurements and results showed small movements of the buildings and very small damage. This paper is aimed at describing the challenges faced for the TBM excavation, the adopted solutions and the most relevant results.

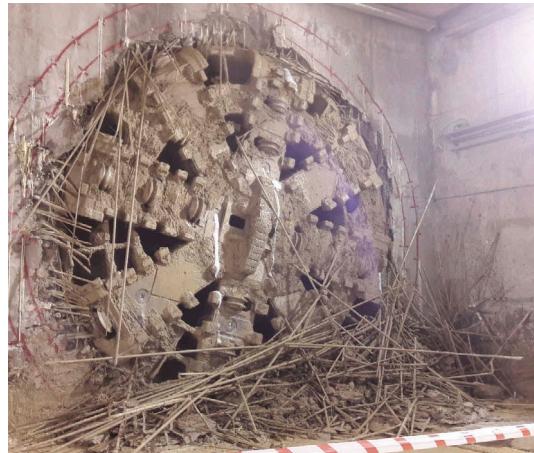
Figure 5. Break-through of the Left TBM at C15 station.

- An appropriate specific configuration of cutting wheel dressing, with 14 disc cutters and additional rippers has been adopted; this was aimed at better protecting the excavation profile of the buckets from the gravels and pebbles encountered along the excavation and

allowed considerable savings in economic terms and time schedule avoiding any additional maintenance stop. This was decided following the arrival of the TBMs into the first station where a high wear of the cutter head tools was noted.

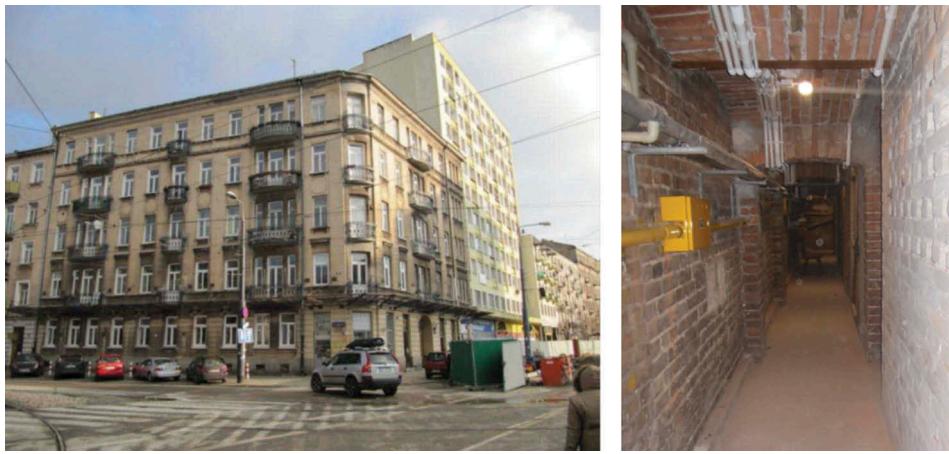
Figure 8. Targowa 84 building external view (left) and basement view (right).

An interesting and delicate case is the building located at 84, Targowa Street. This is a 5-storey masonry corner building (plus basement) built in 1904. This already suffered some settlement from the excavation of C15 station (during the construction works of the Central part of Line II) and is directly above the Left Tunnel excavation. Not only, in order to safely enter the TBMs into the existing C15 station, a jet-grouting plug was foreseen to be installed adjacent to the station d-walls and hence in the immediate vicinity and even below Targowa 84 building. Therefore, a series of works have been carried out (see Figure 9):
